**Total Land Subsidence in the Willcox and Kansas Settlement Areas, Cochise County  
Based on Radarsat-2 Satellite Interferometric Synthetic Aperture Radar (InSAR) Data**

**Time Period of Analysis: 5.0 Years 05/05/2010 To 04/09/2015**

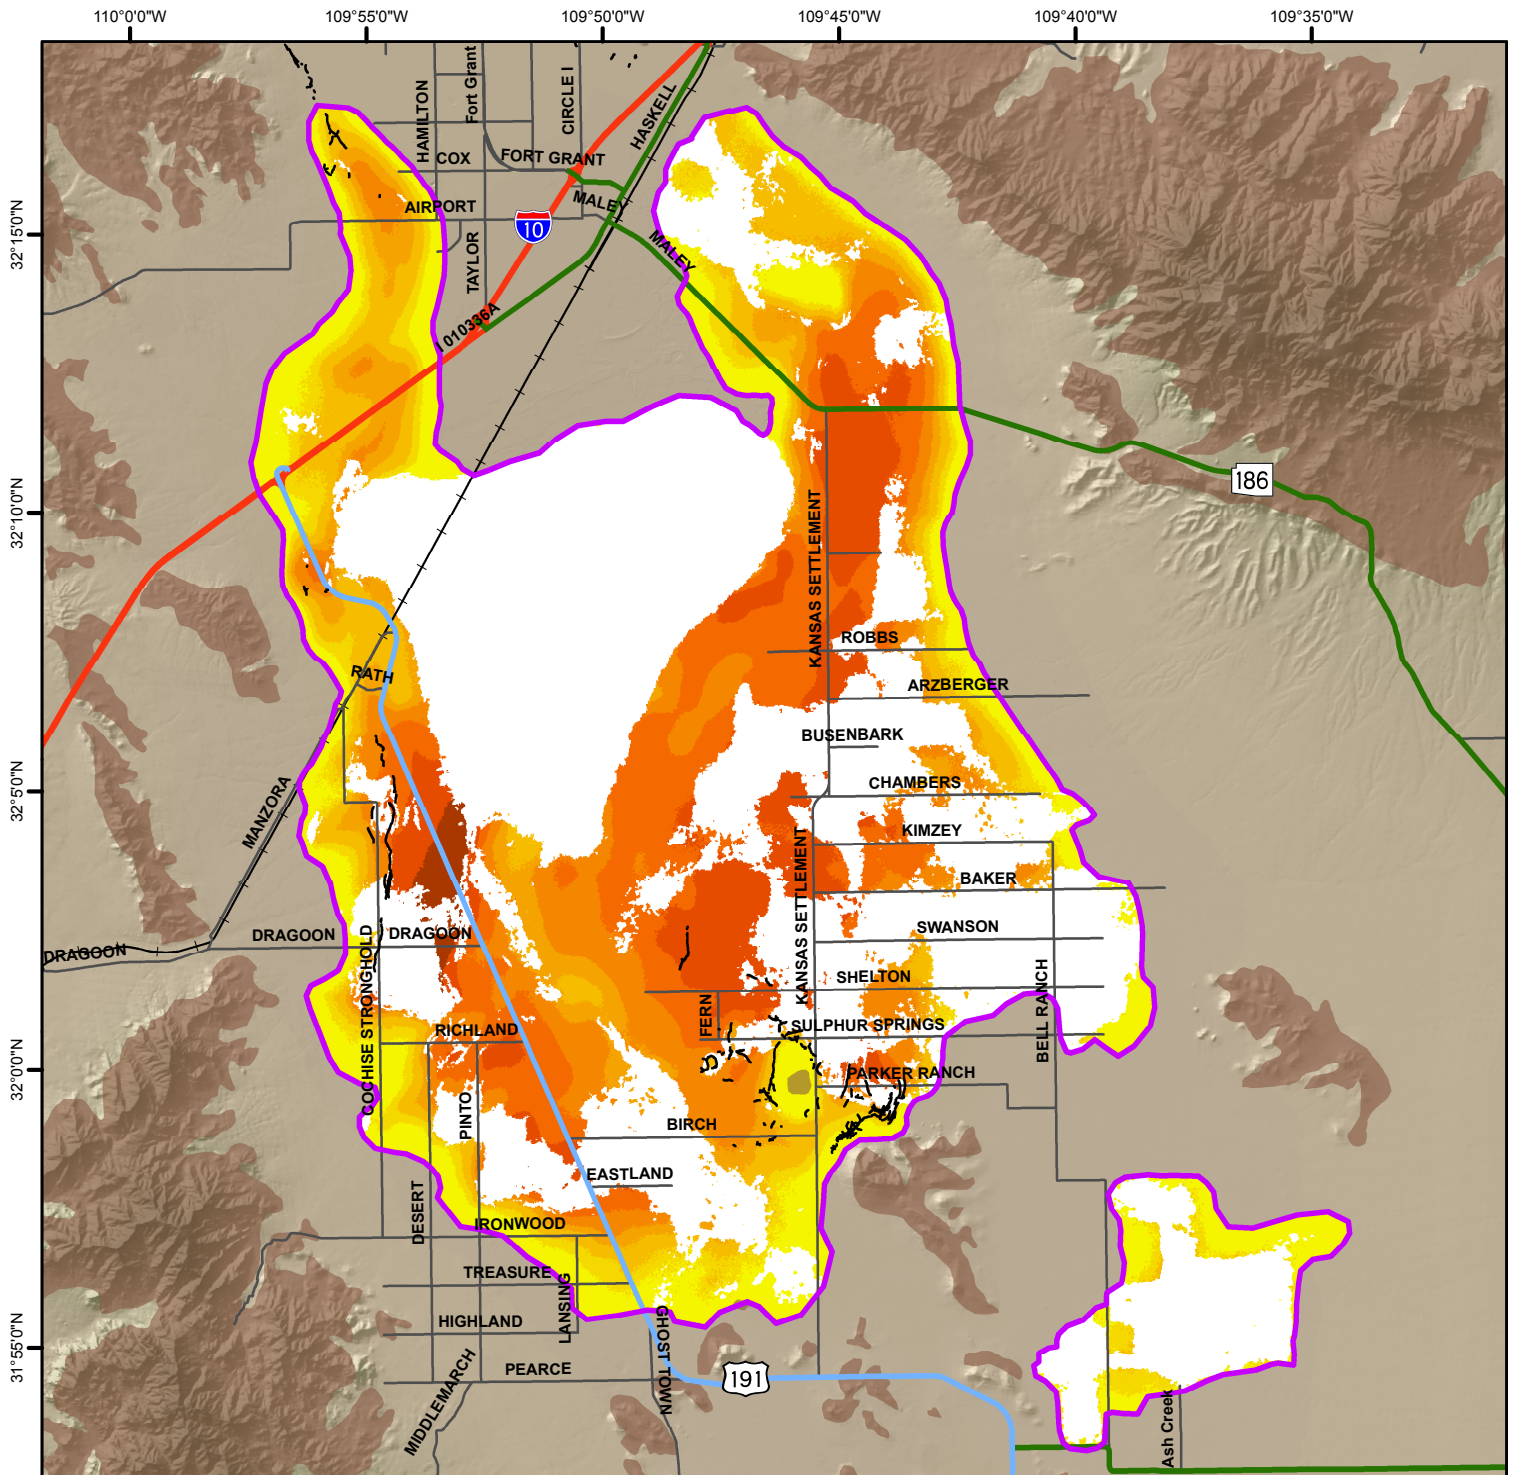
Decorrelation/No Data
Greater 40 cm (15.7 in)
25 - 40 cm (9.8 - 15.7 in)
15 - 25 cm (5.9 - 9.8 in)
10 - 15 cm (3.9 - 5.9 in)
6 - 10 cm (2.4 - 3.9 in)
4 - 6 cm (1.6 - 2.4 in)
2 - 4 cm (0.8 - 1.6 in)
1 - 2 cm (0.4 - 0.8 in)
0 - 1 cm (0 - 0.4 in)

Decorrelation (white areas) are areas where the phase of the received satellite signal changed between satellite passes, causing the data to be unusable. This occurs in areas where the land surface has been disturbed (i.e. bodies of water, snow, agriculture areas, areas of development, etc).

Earth fissures were mapped by the Arizona Geological Survey.  
For information on earth fissures visit: [www.azgs.gov/EFC](http://www.azgs.gov/EFC)
